# Oconto County Lakes Project

## MAIDEN LAKE STUDY SUMMARY REPORT

2018

*University of Wisconsin-Stevens Point and  
Oconto County Staff and Citizens*

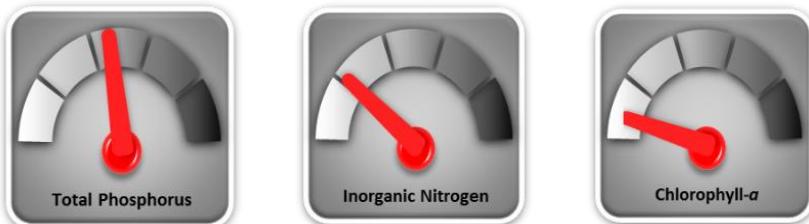
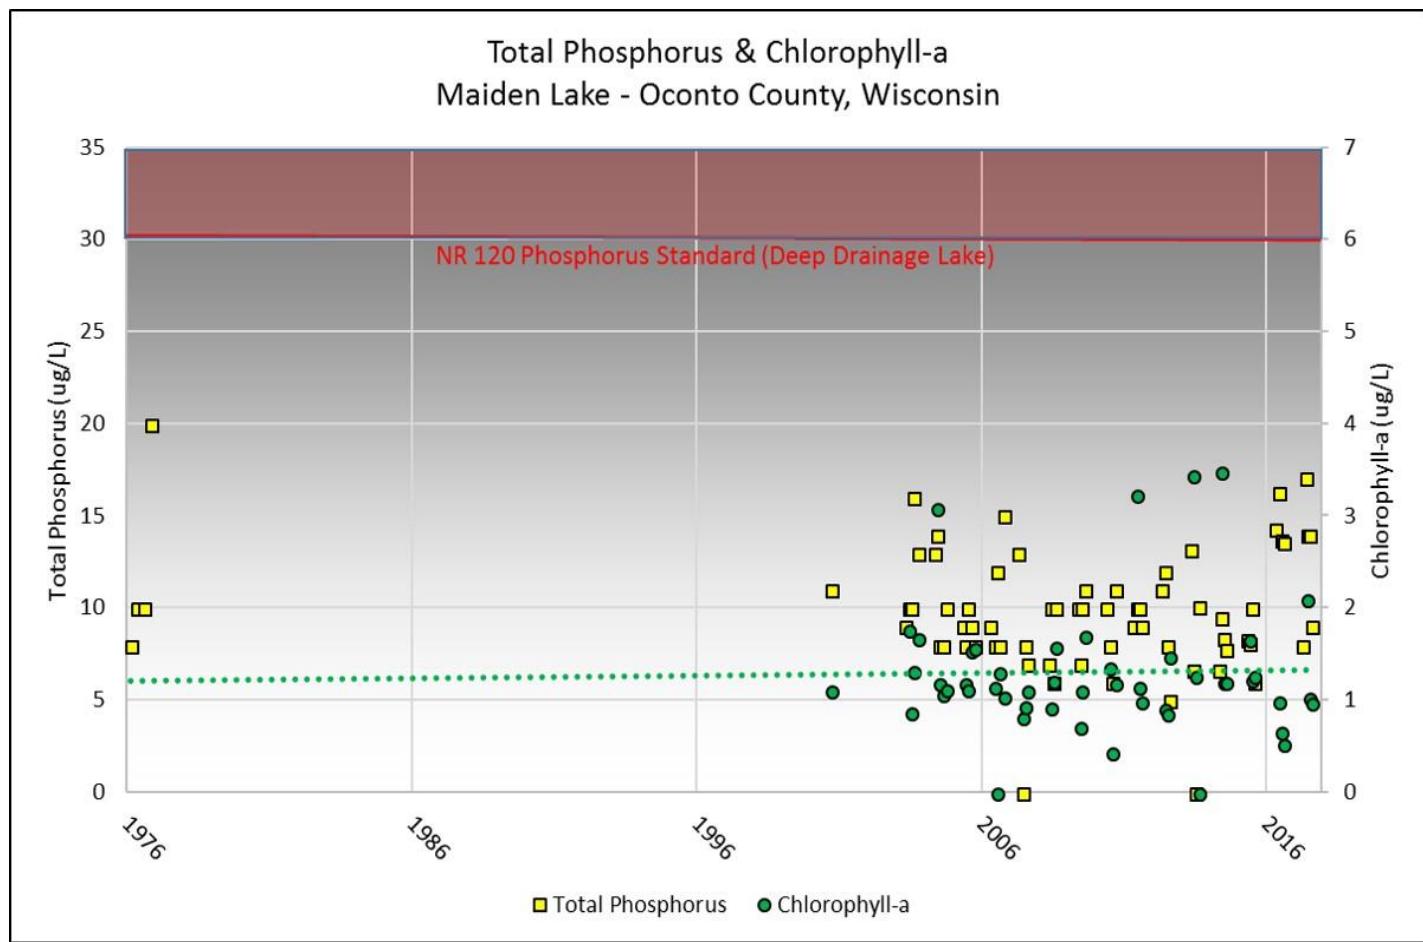
- Total Phosphorus remained well below the Wisconsin state phosphorus standard of 30 ug/L for deep drainage lakes during the two-year study. The long-term trend (based on July data) is slightly increasing.
- Inorganic nitrogen (0.06 mg/L) remained below the threshold of 0.3 mg/L when algal blooms increase.
- Chlorophyll-a, an indirect measure of algae, remained well below 6 ug/L and appears stable.

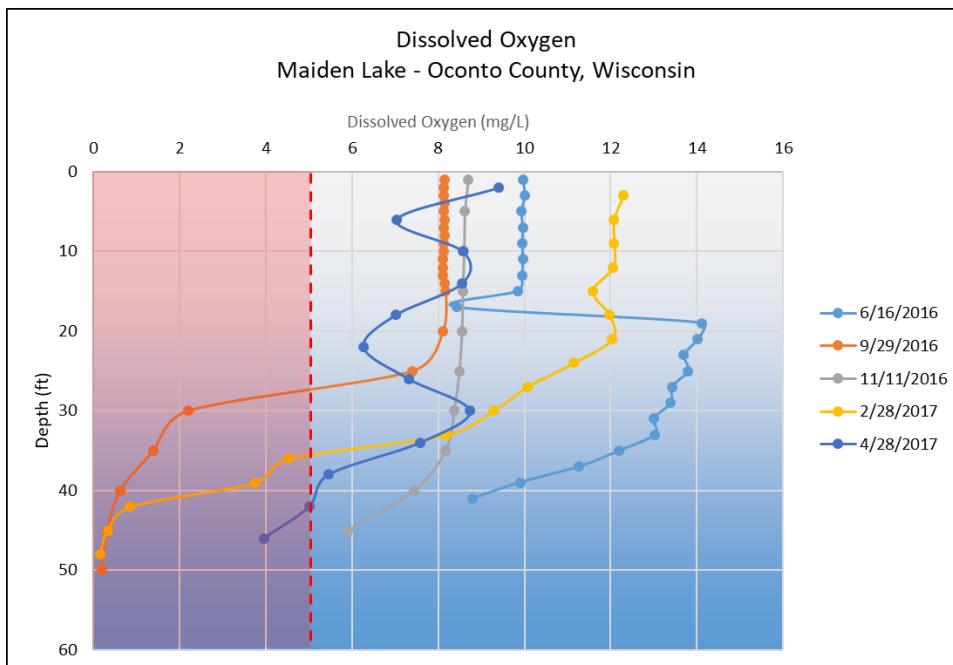
- Sufficient oxygen is available in the top 30 feet of the water column in Maiden Lake throughout the year.
- Bumps in dissolved oxygen concentrations at 15-30 feet suggest mild algal activity.

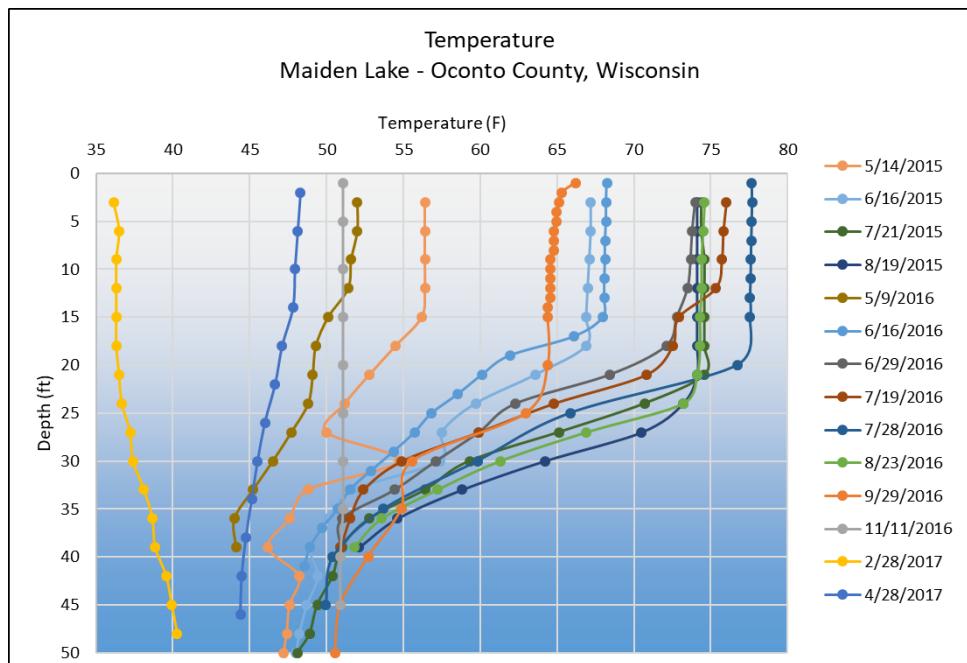
- The temperature gradient in Maiden Lake exhibits a clear thermocline between 20 and 30 feet during the growing season that separates warmer oxygen-rich water at the top from colder oxygen-poor water below.

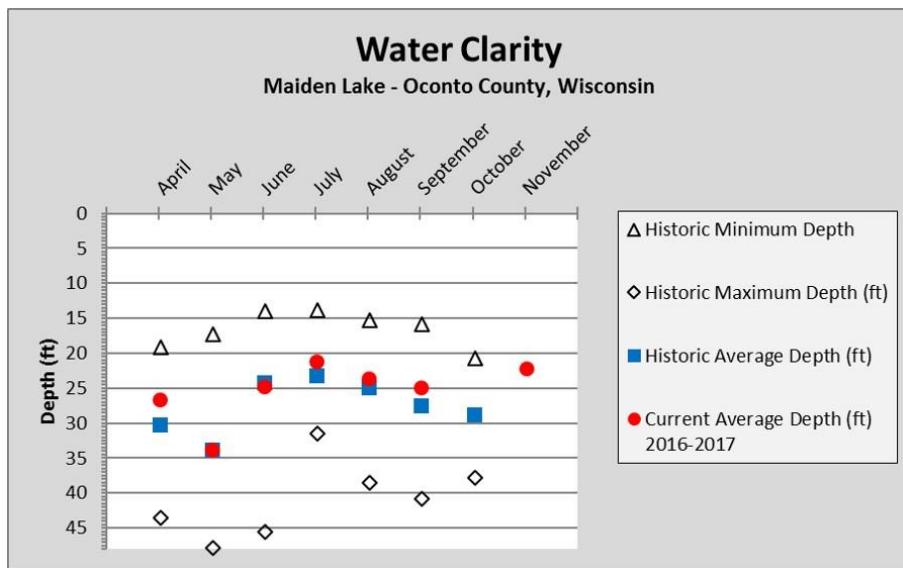
- The graph to the left shows water clarity measurements taken between April and November.
- During 2016-17, on average, the poorest water clarity in Maiden Lake was in July and the best was in May. This is consistent with previous observations and demonstrates an increasing depth trend over the long term (based on July data).

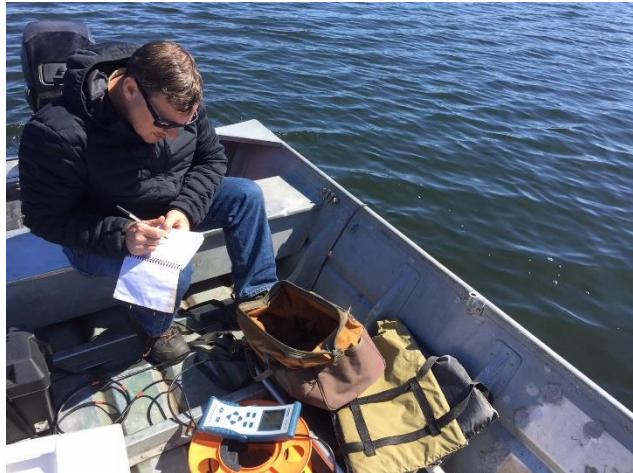
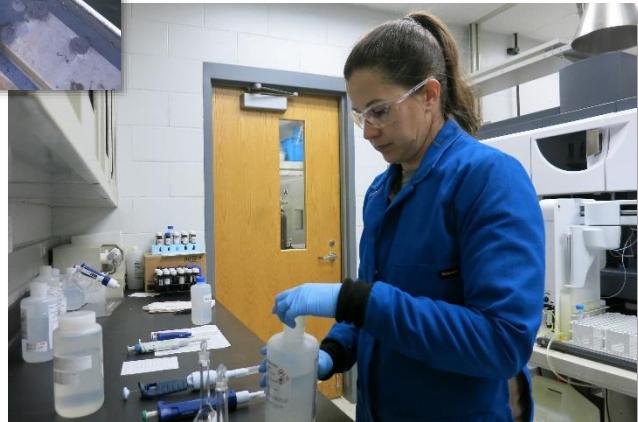
- Concentrations of potassium (1.9 mg/L), chloride (1.1 mg/L) and sodium (1.7 mg/L) were all low. This suggests minimal impact from septic systems, road salt, animal waste and fertilizers.
- DACT, a screening tool to determine if your lake is being impacted by pesticides, was not detected.
- Water in Maiden Lake is hard (135 mg/L CaCO<sub>3</sub>), having a high level of dissolved minerals. Hard water lakes tend to produce more fish and aquatic plants than soft water lakes and have clearer water as the minerals tend to bind with phosphorus making it unavailable to algae blooms.

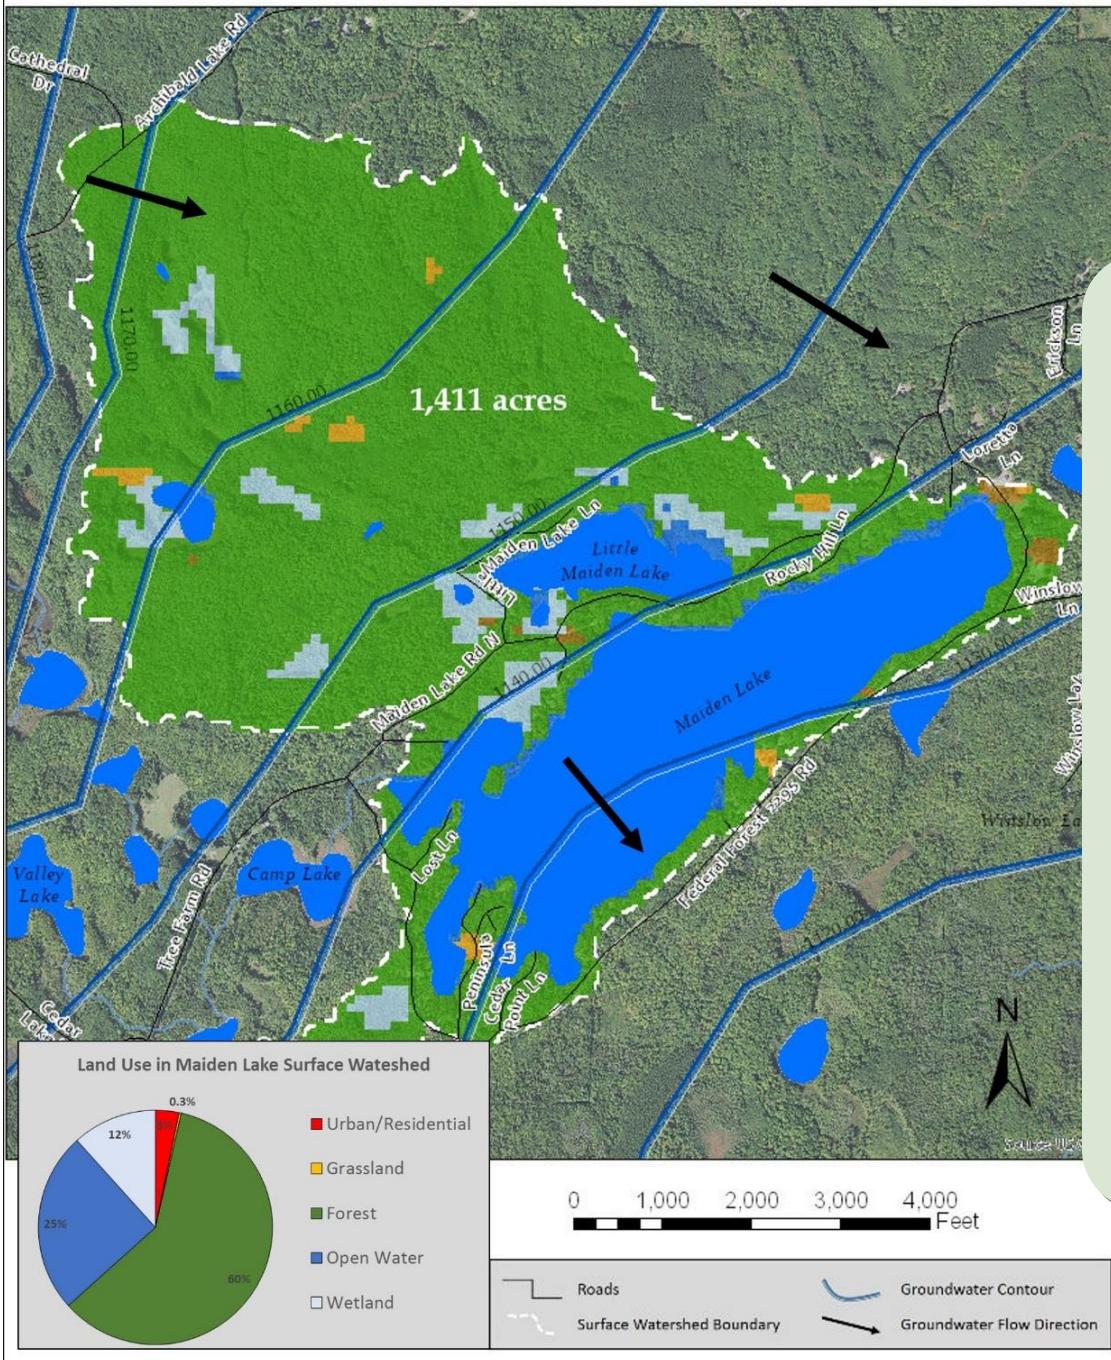
## Maiden Lake Surface Watershed & Groundwater Flow

The quality of groundwater reflects what is happening on the land surface. Precipitation falling on forests produces clean groundwater, whereas precipitation falling on land that has chemical use can leach contaminants to groundwater. Groundwater contamination may include nitrogen, pesticides, herbicides and other soluble chemicals originating from septic systems, crops, barnyards, road de-icing, etc. Once in the groundwater, these chemicals move slowly towards a lake or river.

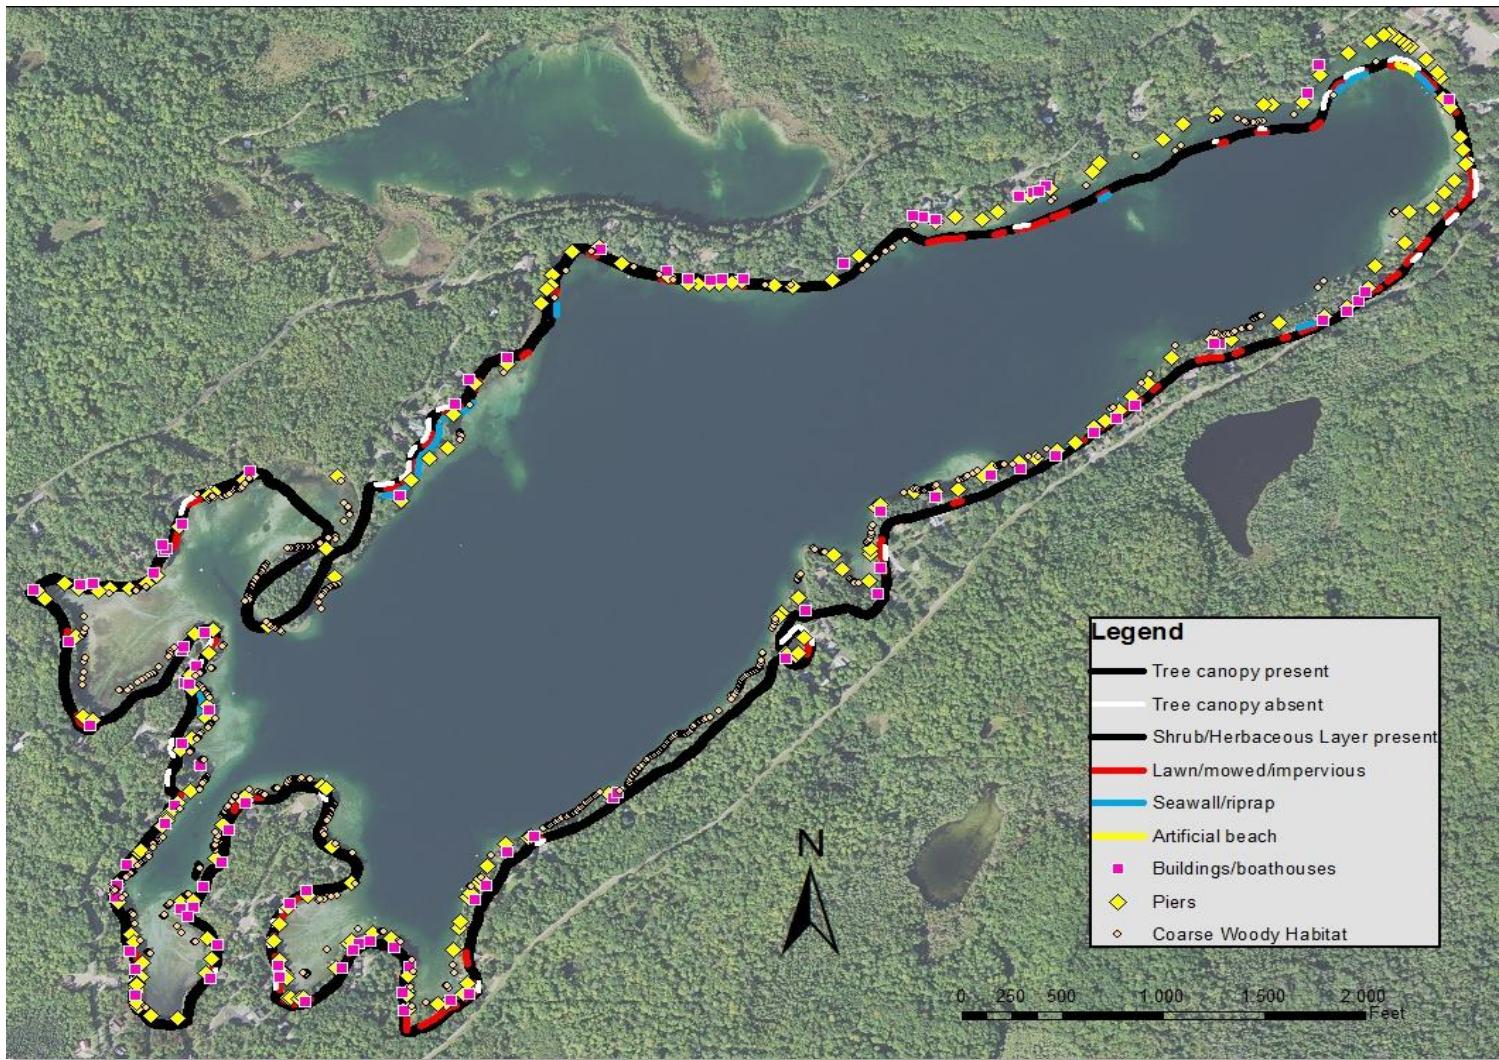
Modifications, Structures, Erosion	Measured Occurrence
Artificial Beach	205 ft
Rip Rap	8,052 ft
Sea Wall	445 ft
Impervious Surface	281 ft
Mowed Lawn	4,980 ft
Erosion	38 ft
Nonconforming Buildings	109
Piers	199
Coarse Woody Habitat	145 logs/mile

- Shorelands around Maiden Lake were surveyed in August 2017. Much of Maiden Lake's shoreland is healthy, but many stretches are in need of restoration.

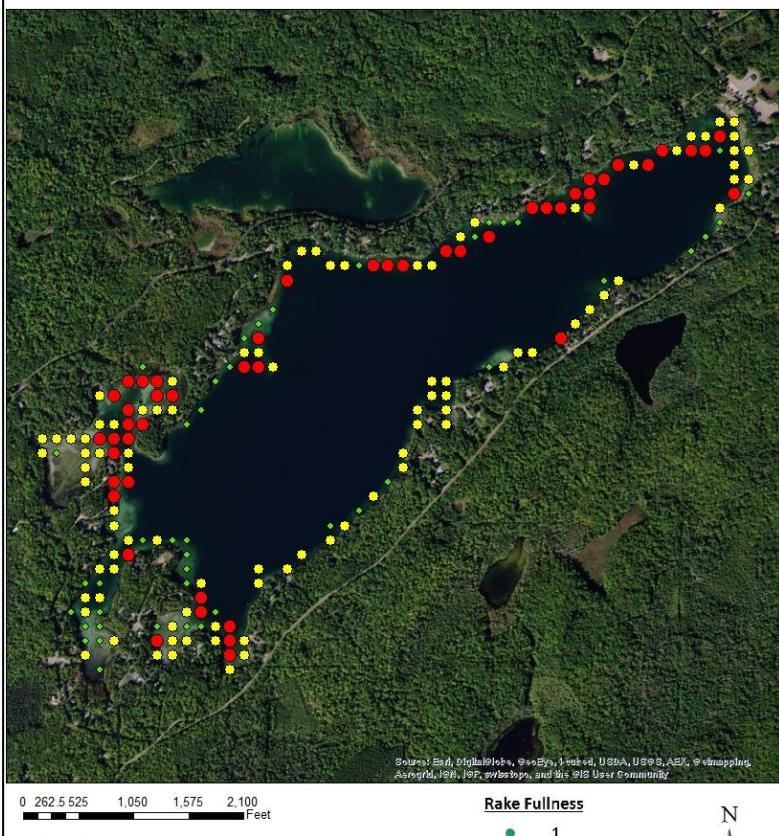
Maiden Lake Aquatic Plant Survey 2016:  
Rake Fullness

- The aquatic plant community in Maiden Lake is characterized high quality vegetation with a floristic quality index (27.7) above the regional average. A total of 34 species were observed in the 2016 survey.
- During the 2016 aquatic plant survey of Maiden Lake, 30% of the sites had vegetative growth. The maximum depth of vegetation was 23 feet.
- The most frequently encountered plant species were chara (96%), nitella (12%), and slender naiad (6%). All three species are native to Wisconsin.

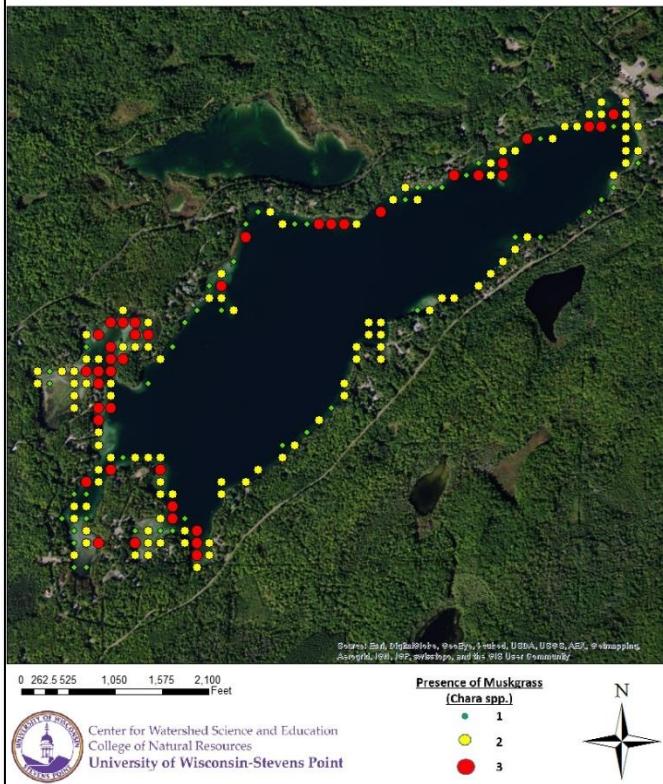
## Maiden Lake Aquatic Plant Survey 2016: Muskgass (Chara spp.)

**Chara** is a type of macro algae that grows attached to muddy lake bottoms and has a musky odor. Muskgrass, as it is known, filters the lake water and is helpful in preventing the establishment of invasive species.

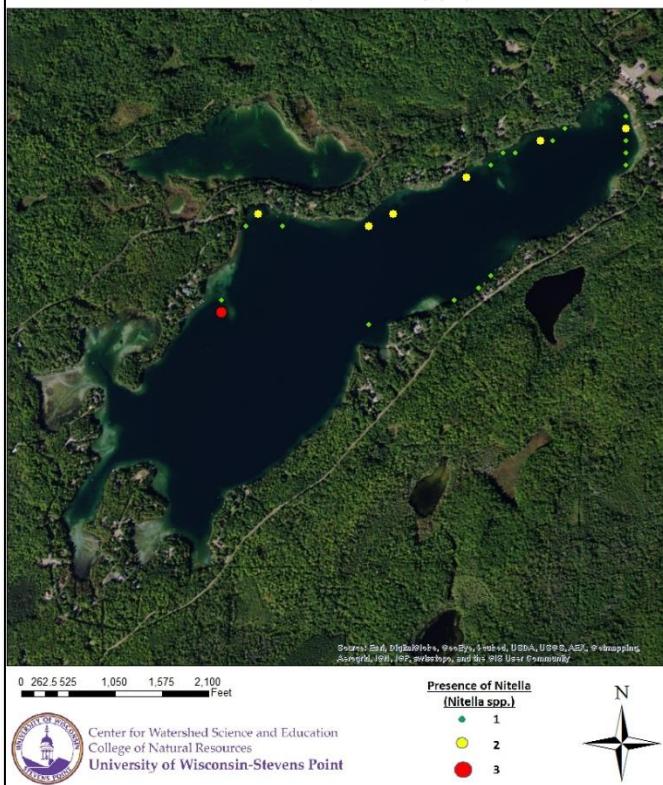
## Maiden Lake Aquatic Plant Survey 2016: Nitella (Nitella spp.)

Like chara, **nitella** is a macroalgae that similarly grows along lake bottoms and can benefit a lake by filtering nutrients from water and preventing establishment of invasive species.

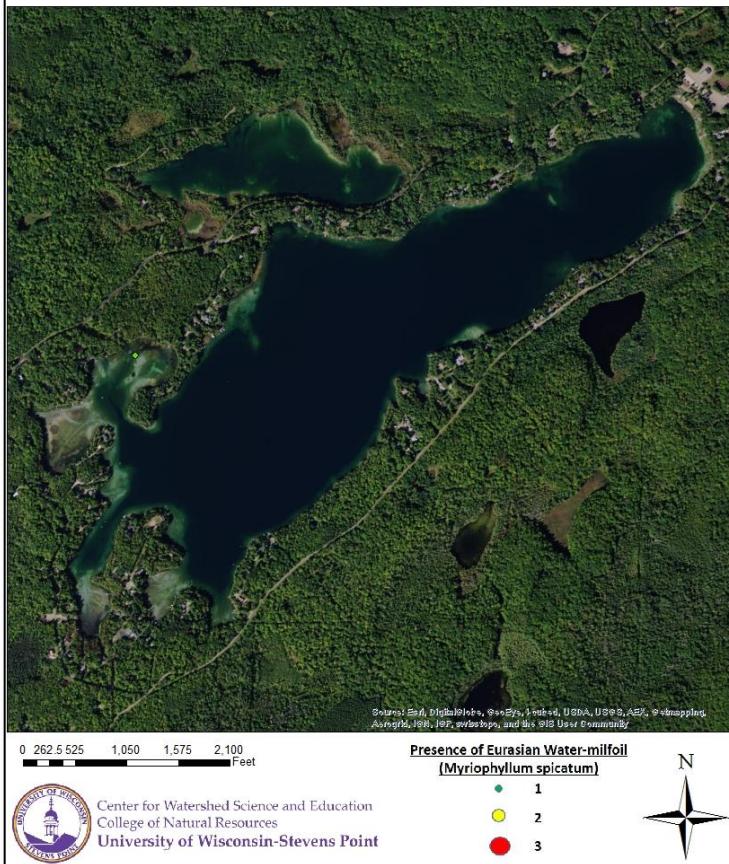
## Maiden Lake Aquatic Plant Survey 2016: Eurasian water-milfoil (*Myriophyllum spicatum*)

Eurasian water-milfoil was observed in one location during the July 2016 aquatic plant survey.

**Eurasian water-milfoil** is one of the most common invasive aquatic plants in Wisconsin. It can form dense mats that choke out native plants and inhibit navigation. New plants can grow from stem fragments that root on contact with the substrate.
