Oconto County Lakes Project

UCIL LAKE STUDY

SUMMARY REPORT

2020

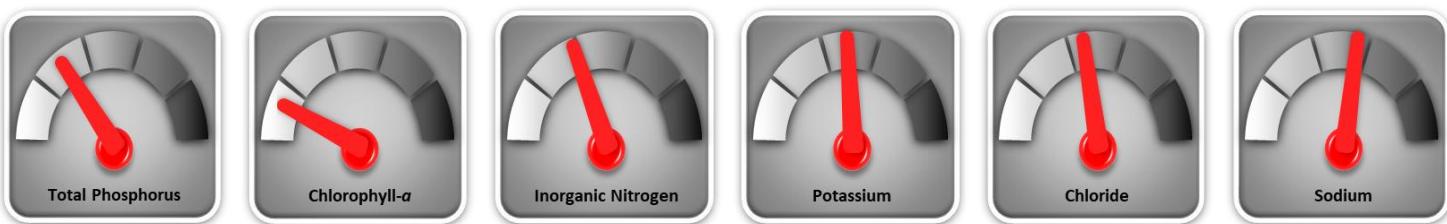
Total Phosphorus & Chlorophyll-a Ucil Lake - Oconto County, Wisconsin

- Total Phosphorus was consistently below the Wisconsin state standard of 40 ug/L for shallow drainage lakes during the two-year study. The long-term trend (based on summer samples) suggests a slightly decreasing average concentration.
- Inorganic nitrogen remained below the threshold of 0.3 mg/L when algal blooms increase.
- Chlorophyll-a, an indirect measure of algae, exceeded the threshold of 6 ug/L in one sample. Not enough data is available to determine a trend.

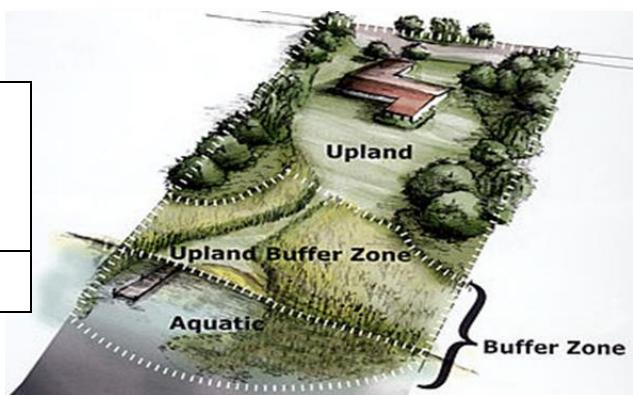
- Shorelands around Ucil Lake were surveyed in August 2018. Much of Ucil Lake's shoreland is healthy, but some stretches are in need of restoration.

Total lakefront footage	No. Riparian lots	Measured shoreland disturbance (feet)	Measured shoreland disturbance (%)
11,785	47	2,968	25%
