Oconto County Lakes Project

GRIGNON LAKE STUDY

SUMMARY REPORT

2022

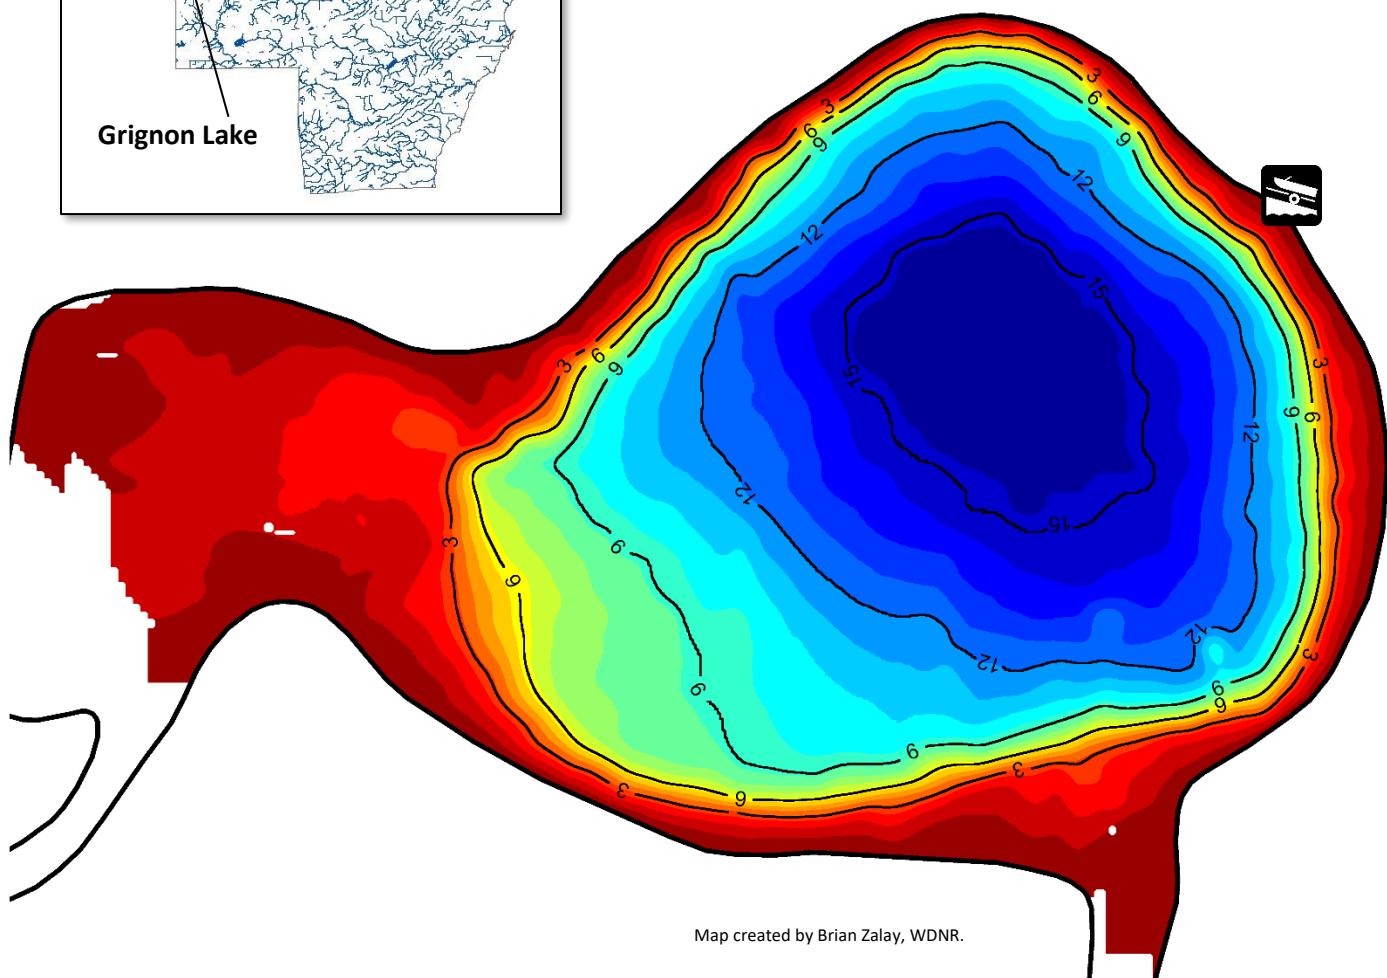
Grignon Lake
Mapping by AutoChart

Map created by Brian Zalay, WDNR.

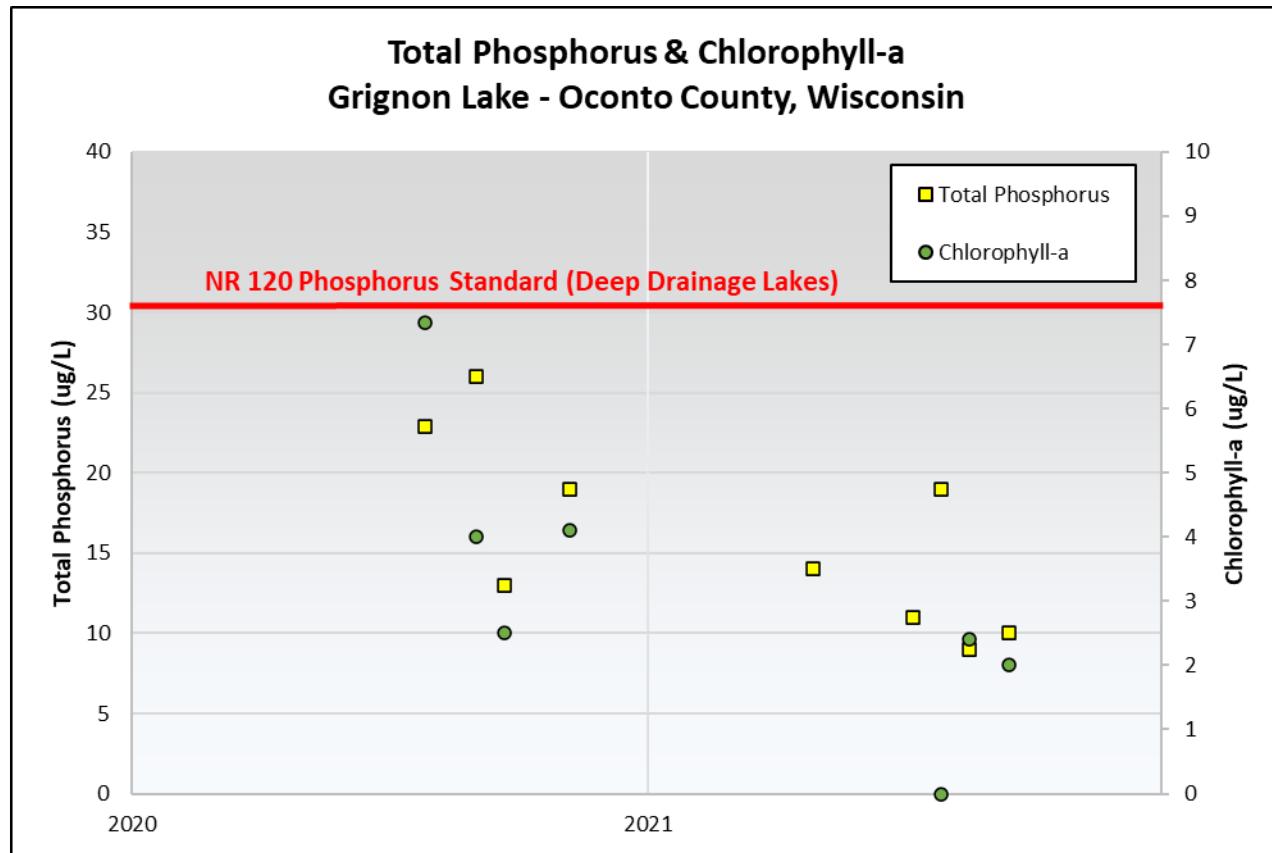
- Total Phosphorus was consistently below the Wisconsin state standard of 30 ug/L for shallow seepage lakes during the two-year study. The limited dataset does not indicate a clear trend.
- Inorganic nitrogen remained below the threshold of 0.3 mg/L when algal blooms increase.
- Chlorophyll-a, an indirect measure of algae, was detected above the threshold of 6 ug/L in one sample.

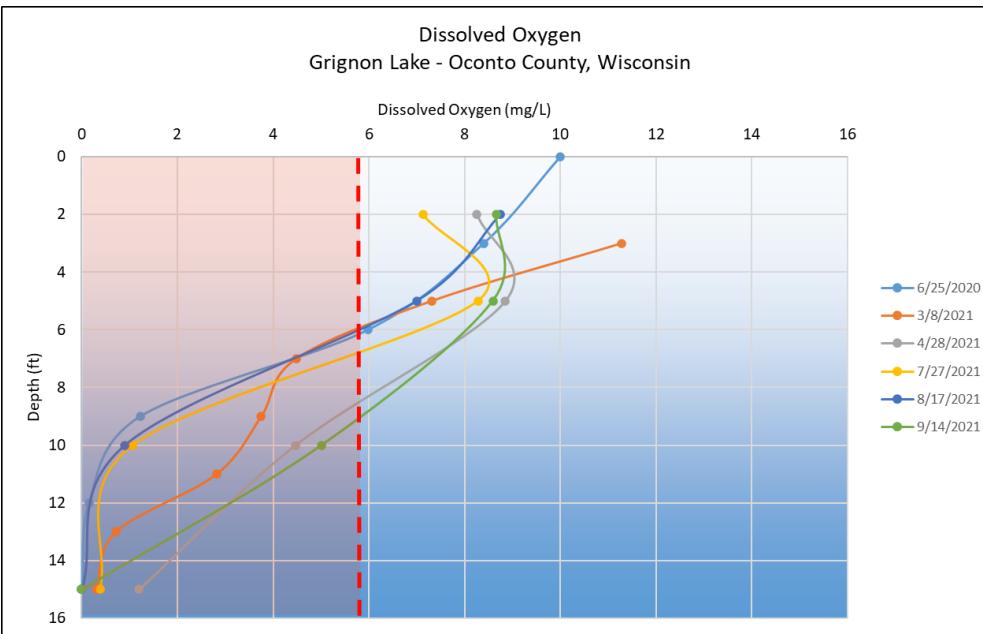
➤ Sufficient oxygen is available in the water column of Grignon Lake throughout the year. Generally, the top 6 feet maintains enough oxygen to support most fish species.

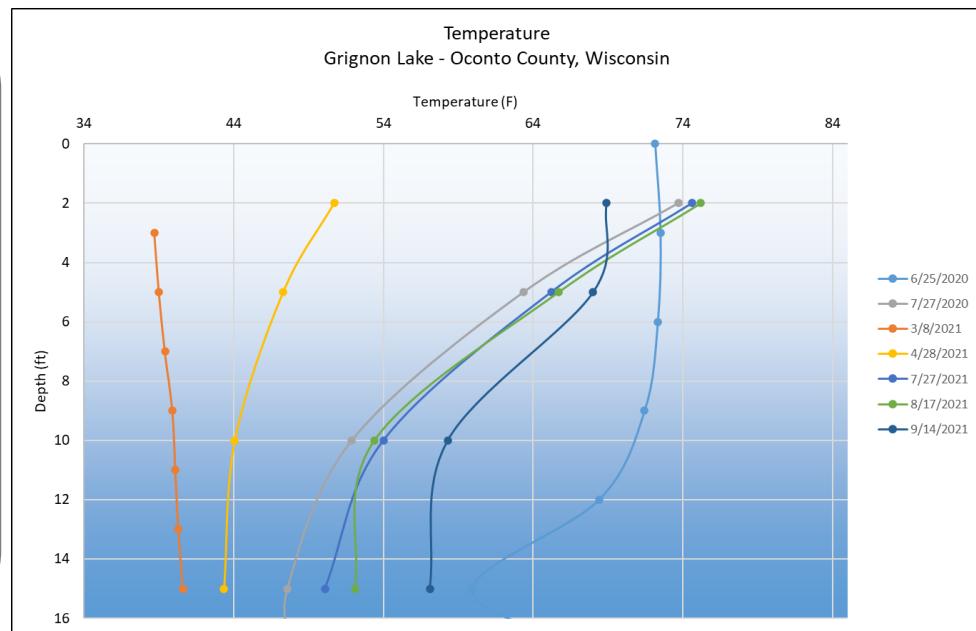
- Most temperature gradients in Grignon Lake show some slight stratification developing as surface temperatures heat up in summer and bottom temperatures represent cool groundwater inputs.

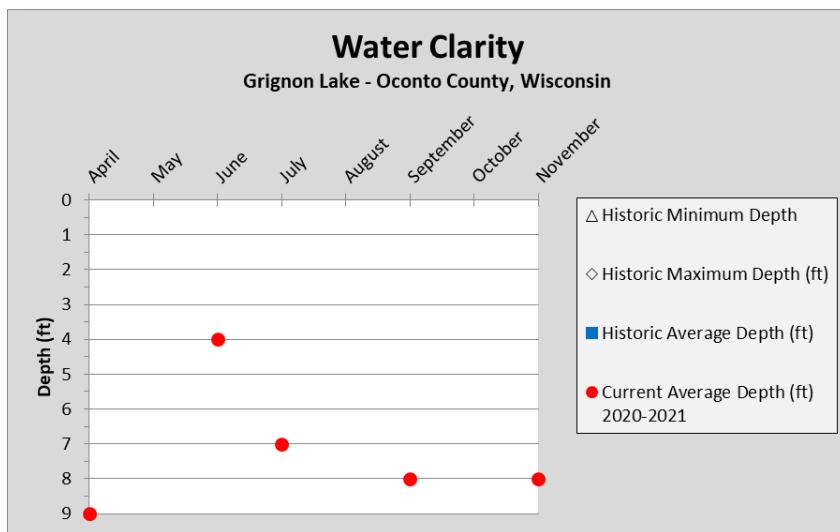
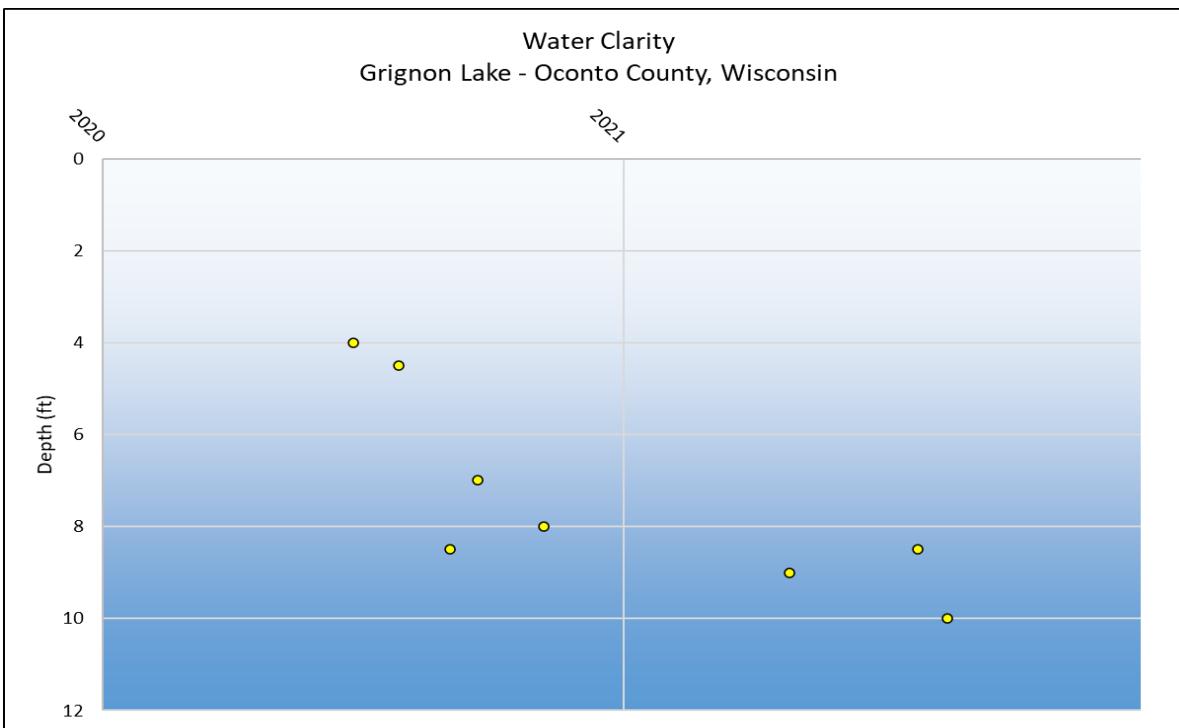
- The graph below shows water clarity measurements taken between May and November.
- During 2020-21, the poorest average water clarity was in June and best was in April. Not enough data is available to determine a trend.

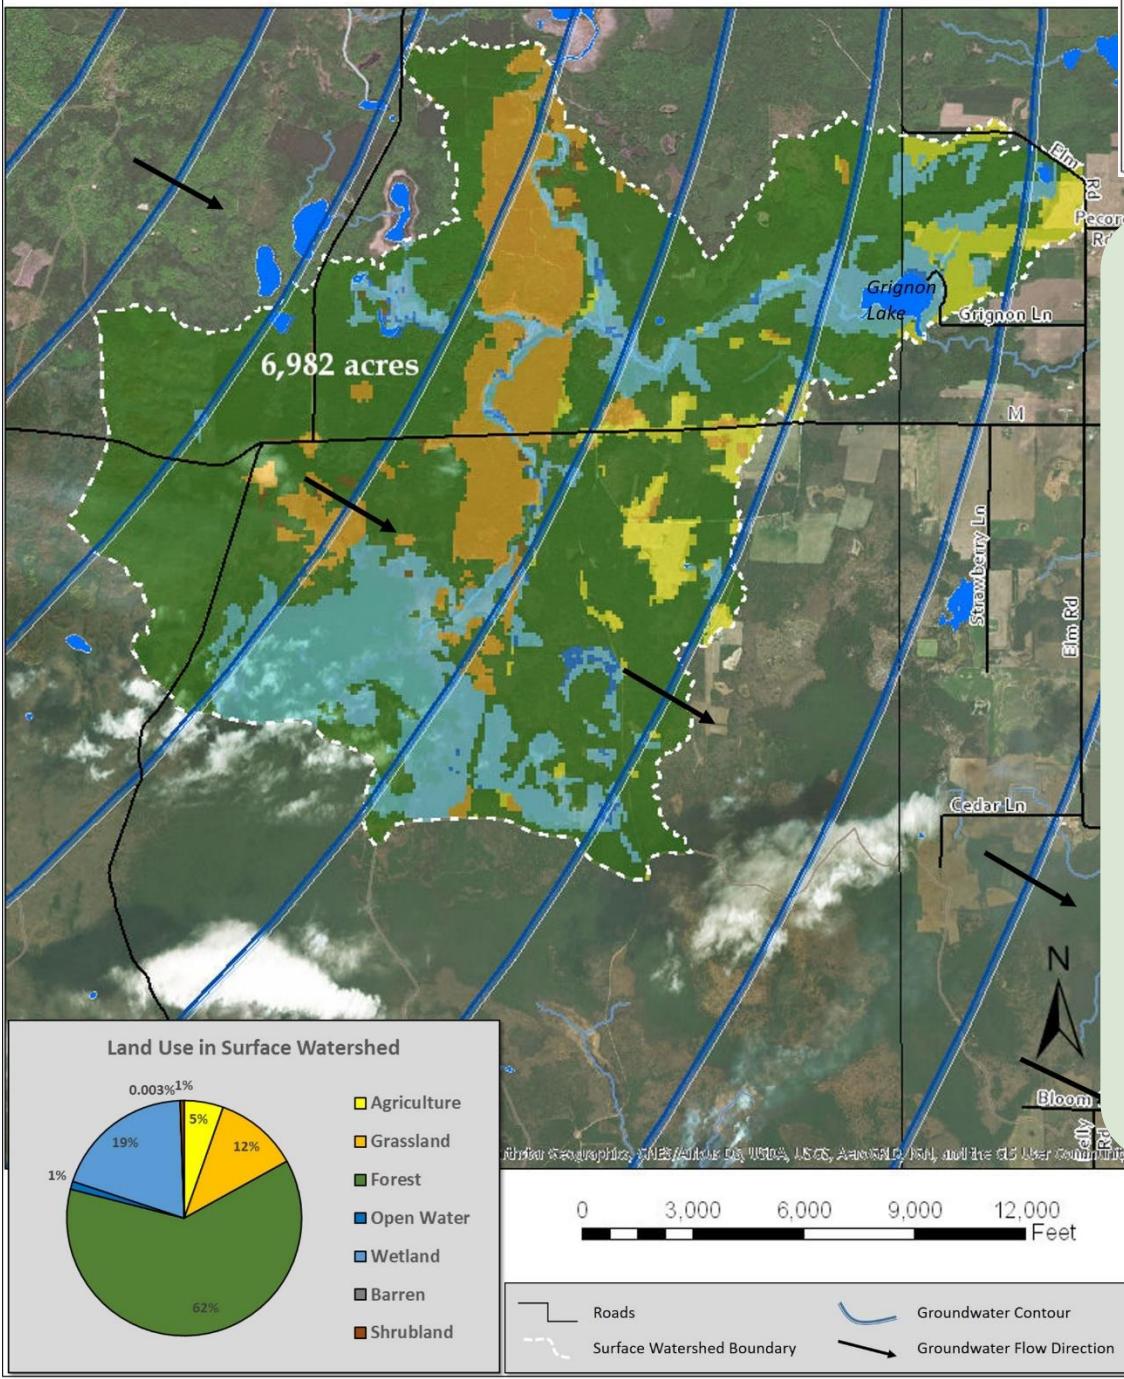
Grignon Lake Surface Watershed & Groundwater Flow

The quality of lake water reflects what is happening on the land surface. Precipitation falling on forests produces clean groundwater, whereas precipitation falling on land that has chemical use can produce runoff and groundwater that contains these chemicals. Groundwater contamination may include nitrogen, pesticides, herbicides and other soluble chemicals originating from septic systems, crops, barnyards, and road de-icing. Once in the groundwater, these chemicals move slowly towards a lake or river.

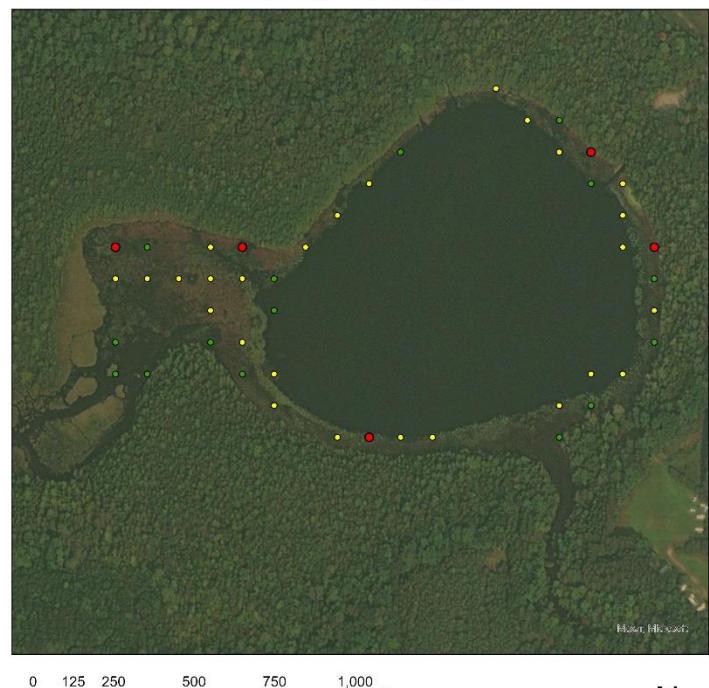
Grignon Lake Aquatic Plant Survey 2020:
Rake Fullness

- The aquatic plant community in Grignon Lake is characterized by average diversity of plant species when compared to other lakes in the Oconto County Lakes Project, with a total of 20 species in the 2020 survey.
- During the 2020 aquatic plant survey of Grignon Lake, 38% of visited sites had vegetative growth. The maximum depth of vegetation was 7.5 feet and the Floristic Quality Assessment (FQI) was 26.
- The most frequently encountered plant species were coontail (57%), spatterdock (39%) and Northern wild rice (43%). All three species are native to Wisconsin.
- No invasive species were observed.

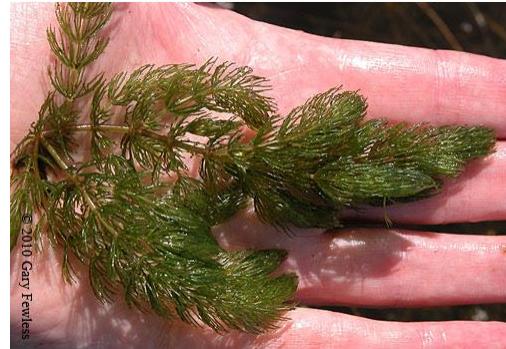
Coontail lacks roots and can form dense mats just below the surface. It is usually in calm, nutrient-rich water and provides habitat for young fish and other aquatic animals. Waterfowl will eat the seeds and foliage.

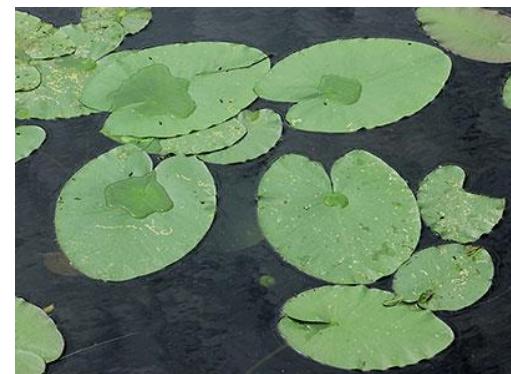
Spatterdock, or yellow pond lily, can be a valuable plant for fish and wildlife habitat providing food, shelter, and a place of breeding for many. Leaves provide shade, shelter, and cover from predators for many invertebrates that fish use for food. Seeds are eaten by waterfowl and other birds. Muskrat, beaver, and porcupine will eat the rhizomes and deer have been known to graze on leaves and flowers.

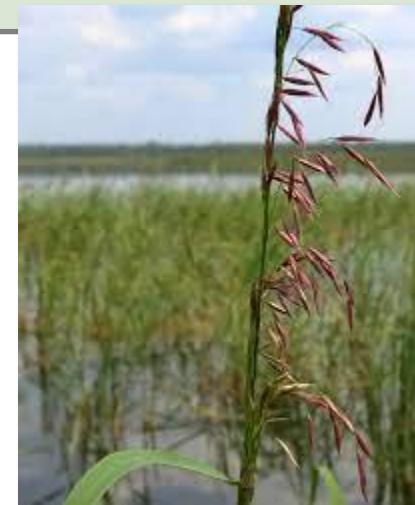
Wild rice is one of the only grains native to North America. Not directly related to Asian rice, Wild Rice is not really rice, but an aquatic grass. It sprouts under water in late April or early May, producing a single root and submerged thin ribbon-like leaves. In June, leaves that float on the surface of the water are produced. During this time, adventitious roots sprout near the first few nodes of the stem, and in early July leaves appear above the water. The heads appear by the end of July with female flowers at the top and male flowers at the bottom.
