# Oconto County Lakes Project

## MARY LAKE STUDY SUMMARY REPORT 2024

# Background

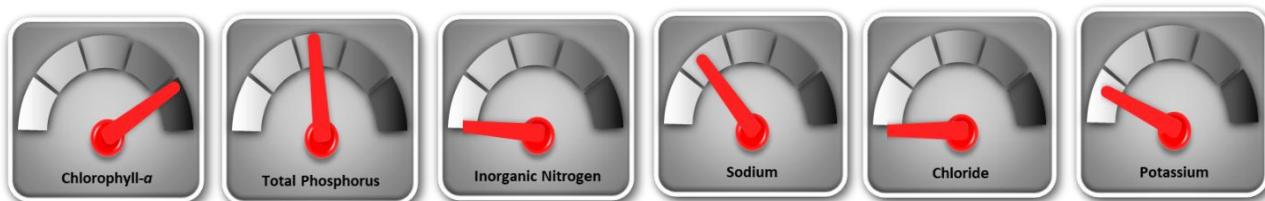
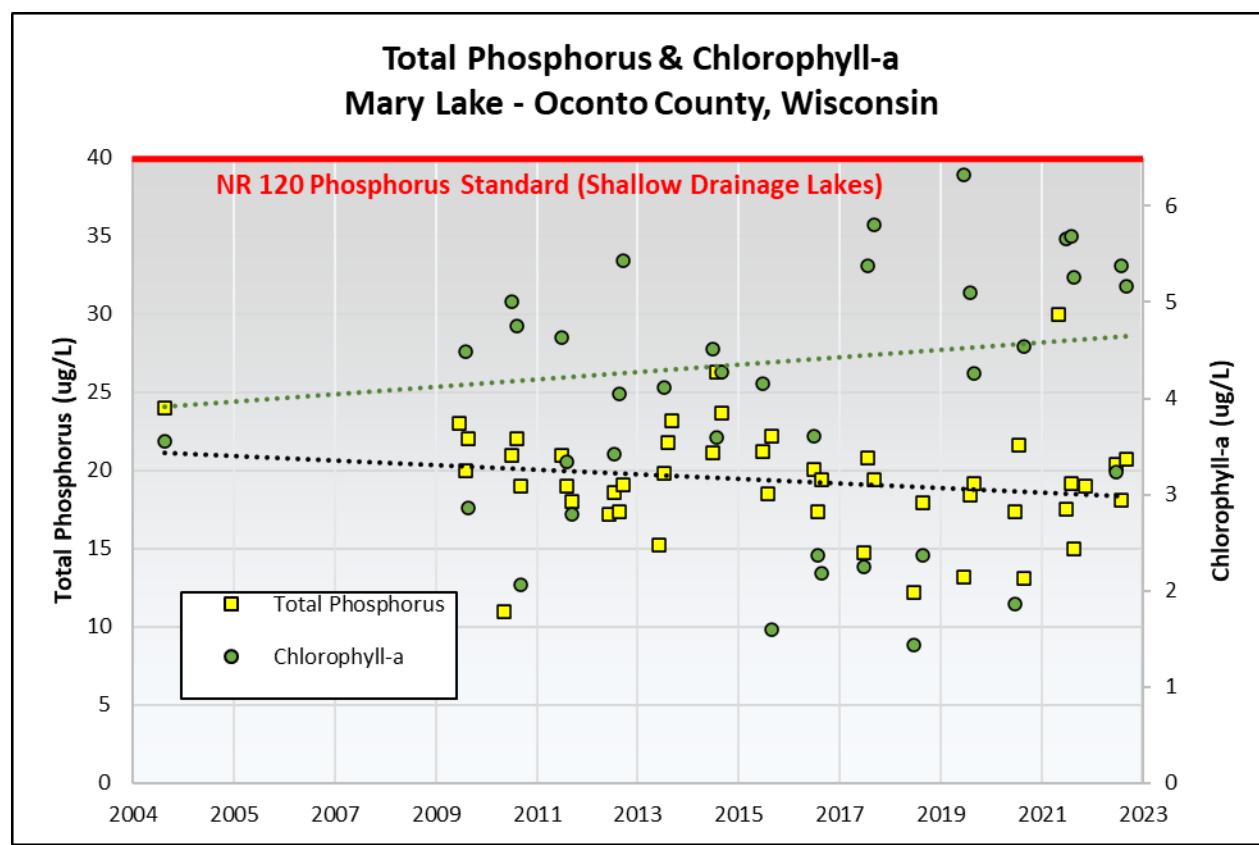
- Total Phosphorus was consistently below the Wisconsin state standard of 40 ug/L for shallow drainage lakes during the two-year study. The 20-year data trend suggests a slightly decreasing average concentration.
- Inorganic nitrogen remained below the threshold of 0.3 mg/L when algal blooms increase.
- Chlorophyll-a, an indirect measure of algae, was slightly elevated nearing the threshold of 6 ug/L when nuisance algae blooms typically occur. The 20-year trend suggests a slight increase in these concentrations.

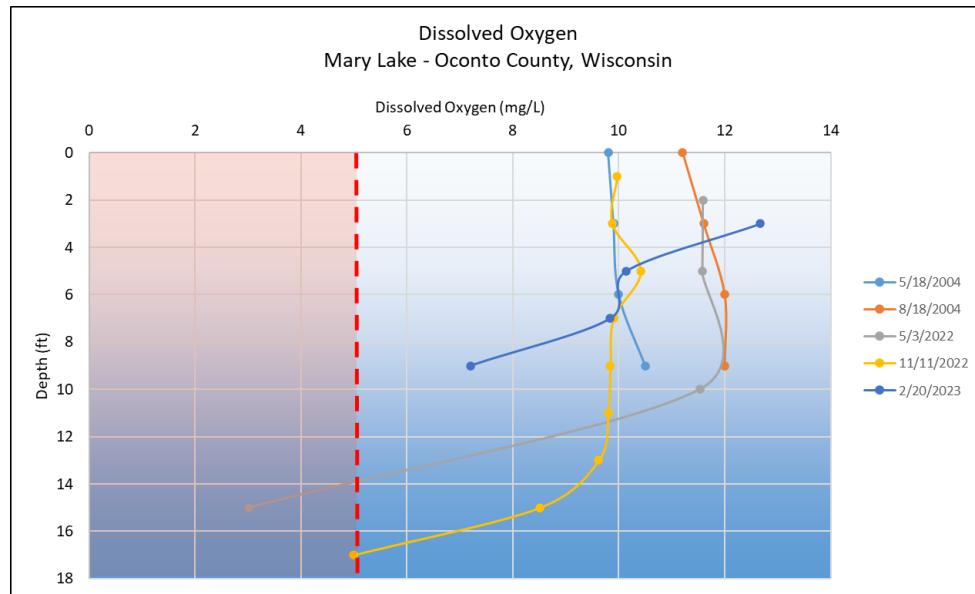
Sufficient **dissolved oxygen** in lake water is essential to the survival of aquatic organisms. The amount of dissolved oxygen present within a lake varies by season and depth. It is determined by the biological activity that consumes or produces oxygen, by water mixing through wind, changes in temperature, and inputs of surface and groundwater. Generally, at least 5 mg/L oxygen is required for fish.

- Sufficient oxygen is available in the water column of Mary Lake throughout the year. Generally, the top 10-14 feet maintains enough oxygen to support most fish species, even in late winter.

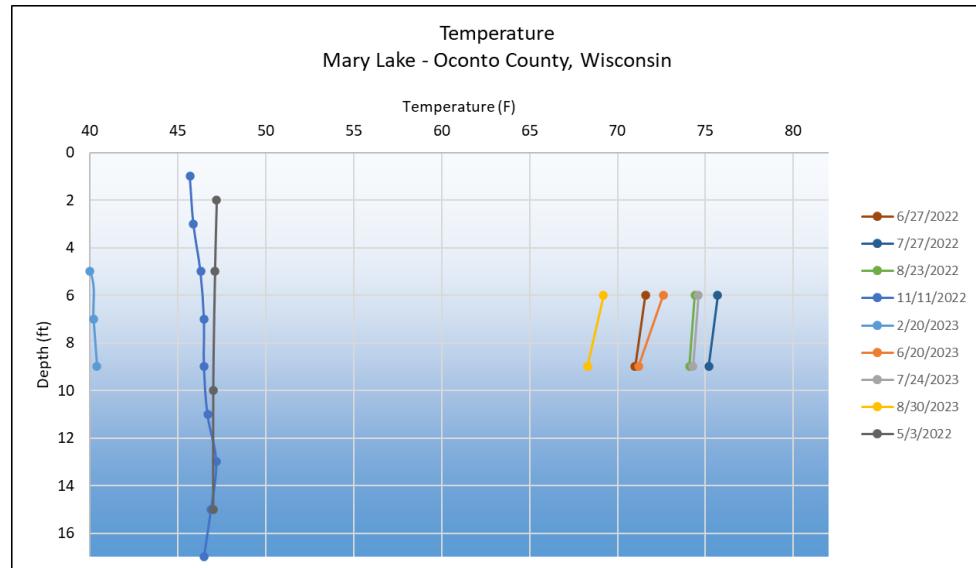
Lake water **temperature** has a significant impact on water chemistry, spatial distribution of fish, microbial growth and oxygen content.

- Temperature profiles in Mary Lake show similar temperature with depth, typical of a shallow, mixed lake.

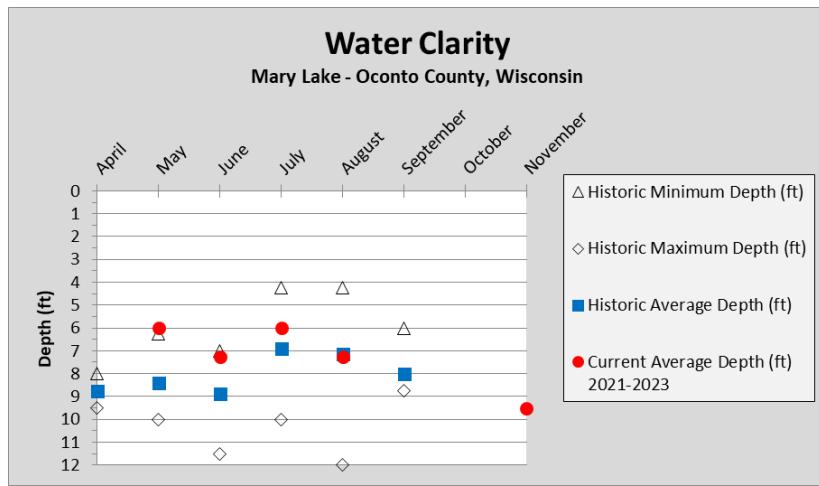
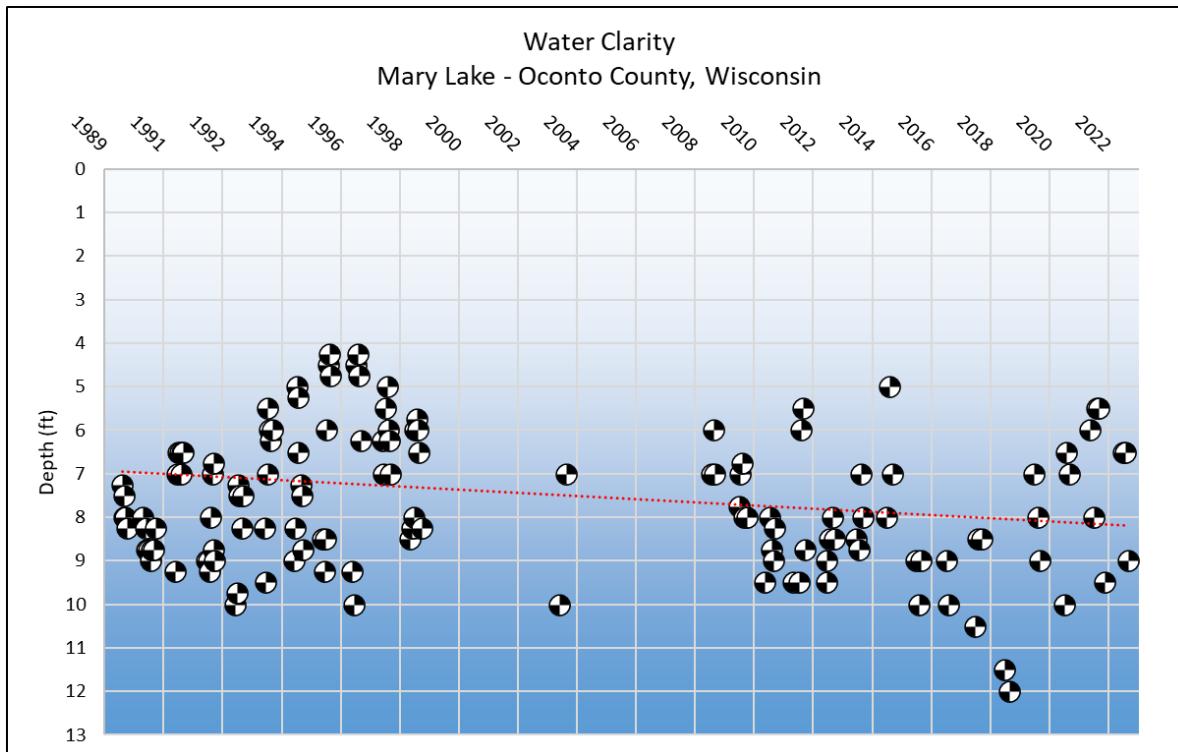
**Water clarity** is a measure of how deep light can penetrate (Secchi depth). Clarity is affected by water color, turbidity (suspended sediment), and algae. Water clarity helps determine where rooted aquatic plants can grow. It is typical for water clarity to vary throughout the year.

- The graphs below show water clarity measurements taken between May and November.
- During 2022-23, water clarity was best in November and worst in July. The long-term trend suggests increasing average clarity.

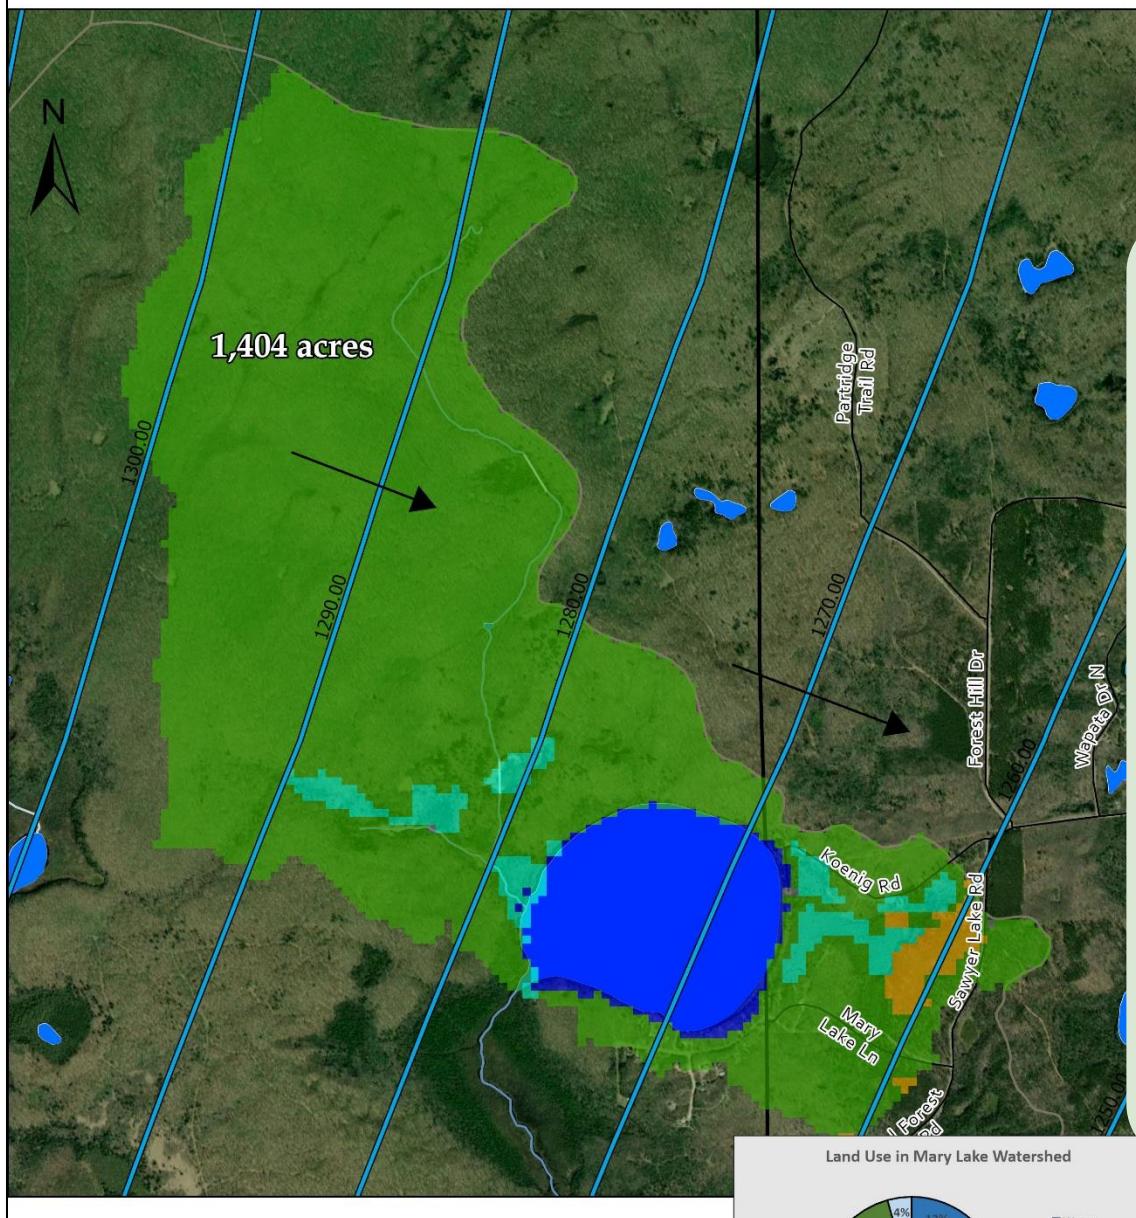
## Mary Lake Surface Watershed & Groundwater Flow

**Groundwater** provides water to lakes in Oconto County throughout the entire year. Hard surfaces on the landscape prevent water from soaking into the ground and becoming groundwater. This results in less water flowing to the lake during snowmelt and rain events. Water that does not infiltrate to groundwater becomes **surface runoff** flowing across the surface of the landscape where it can move sediment and contaminants to the lake from within its watershed.

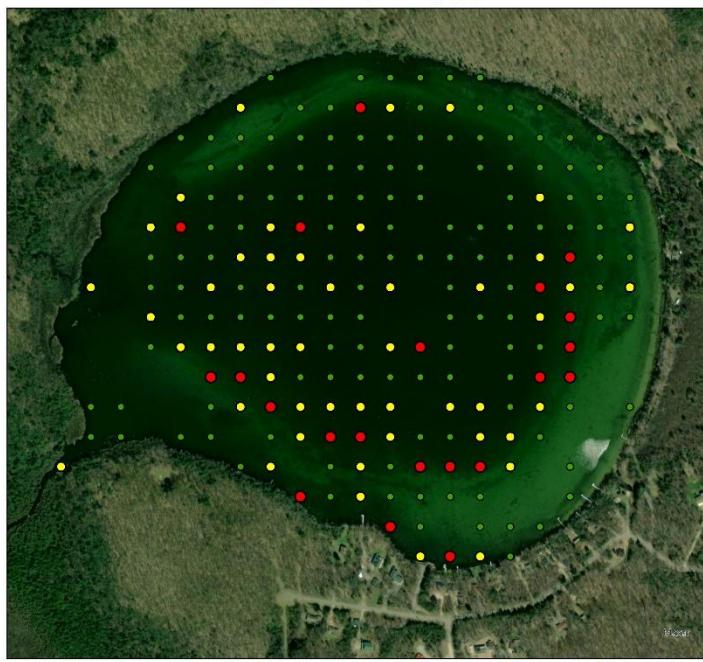
## Mary Lake Aquatic Plant Survey 2022: Rake Fullness

- The aquatic plant community in Mary Lake is characterized by slightly average diversity of plant species when compared to other lakes in the Oconto County Lakes Project, with a total of 22 species in the 2022 survey.
- During the 2022 aquatic plant survey of Mary Lake, 81% of visited sites had vegetative growth. The maximum depth of vegetation was 13 feet and the Floristic Quality Assessment (FQI) was 24.5.
- The most frequently encountered plant species were slender naiad (65%), chara (50%), and flat-stem pondweed (11%).
- No invasive species were observed.

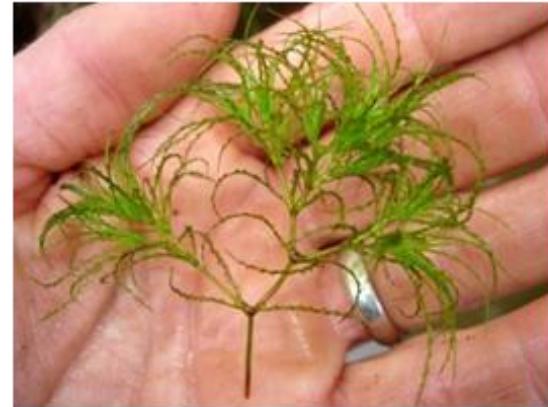
**Slender naiad** has glossy, finely toothed leaves appearing as whorls near the end of stems. Also known as the water-nymph, the whole plant is eaten by waterfowl and provides shelter for small fish and insects.

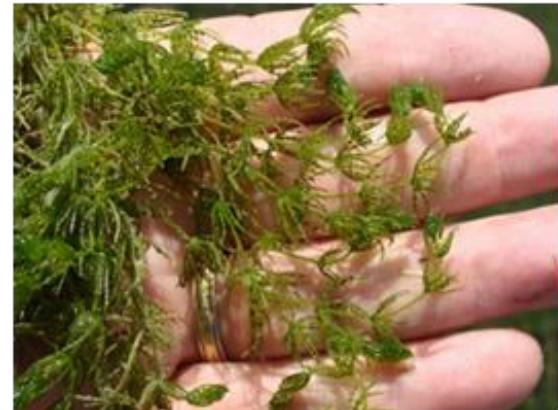
**Chara** is a type of macro algae that grows attached to muddy lake bottoms and has a musky odor. Muskgrass, as it is known, filters the lake water and is helpful in preventing the establishment of invasive species.

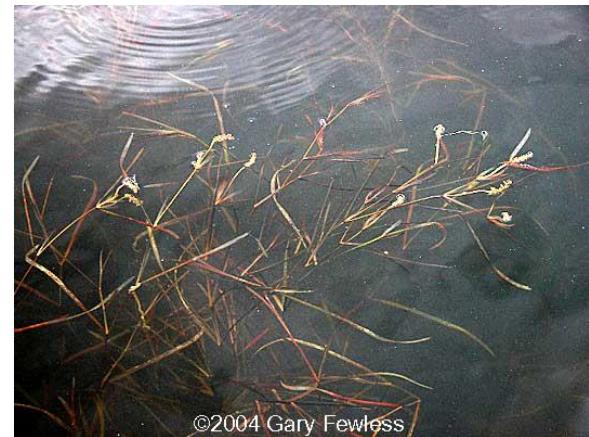
**Flat-stem pondweed**, usually found in soft sediment, is a food source for geese and ducks and some mammals. It provides food and cover for fish and invertebrates.

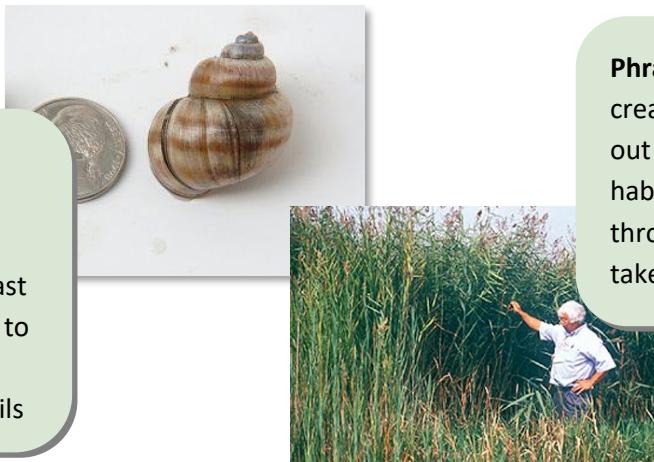
**Banded mystery snails** are born as fully formed snails that seem to appear from nowhere. Native to southeast US, they have the potential to serve as hosts for parasites and outcompete native snails
