Oconto County Lakes Project

MOODY LAKE STUDY SUMMARY REPORT

2024

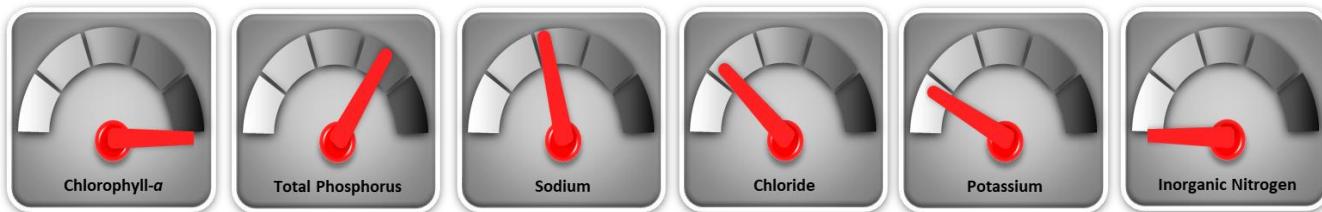
- Total Phosphorus was periodically above the Wisconsin state standard of 40 ug/L for shallow seepage lakes during the two-year study. The long-term trend suggests this average concentration is increasing slightly.
- Inorganic nitrogen remained below the threshold of 0.3 mg/L when algal blooms increase.
- Chlorophyll-a, an indirect measure of algae, remained below the threshold of 6 ug/L during the study.

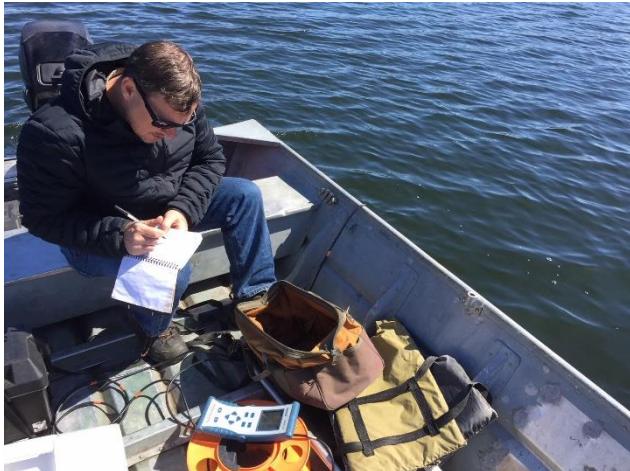
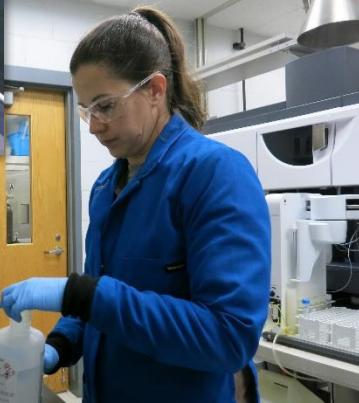
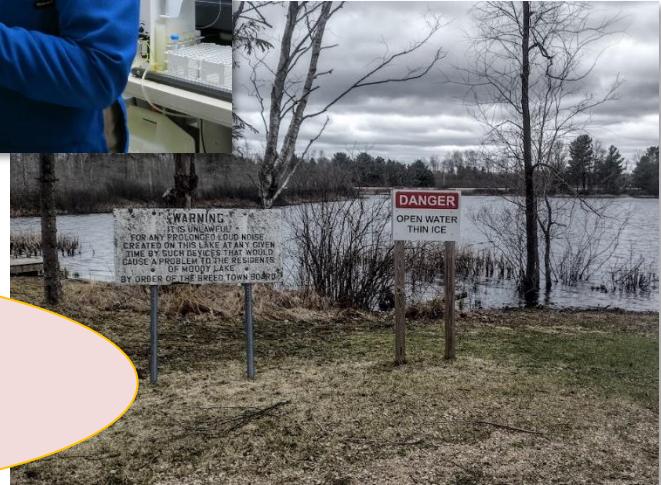
- Concentrations of potassium (0.871 mg/L), chloride (2.5 mg/L) and sodium (2.5 mg/L) were low. This suggests minimal impacts from human activity such as septic systems, road salt, animal waste and fertilizers.
- DACT, a screening tool to determine if your lake is being impacted by pesticides, was not detected.
- Water in Moody Lake is soft (10 mg/L CaCO₃), having a low level of dissolved minerals. These are minerals tend to bind with ions like phosphorus making it unavailable. As a result, Moody Lake has a low tolerance for excess nutrients.

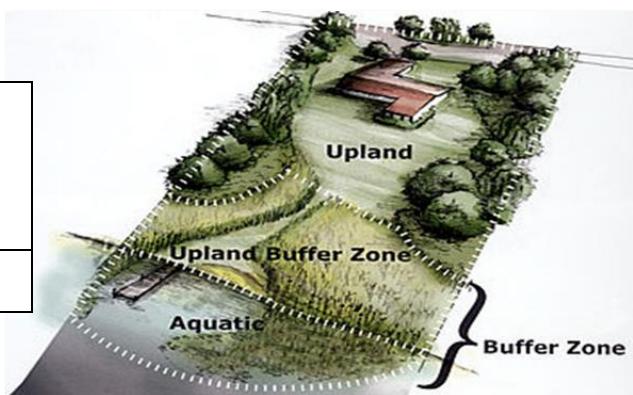
- Shorelands around Moody Lake were surveyed in August 2022. Much of Moody Lake's shoreland is healthy, but some sections are in need of restoration.

Total lakefront footage	No. Riparian lots	Measured shoreland disturbance (feet)	Measured shoreland disturbance (%)
1,324	23	446	34%
