PUBLIC INVOLVEMENT MEETING

SMYTH ROAD BRIDGE
over the OCONTO RIVER
NORTH BRANCH

WisDOT Project ID 9077-04-00

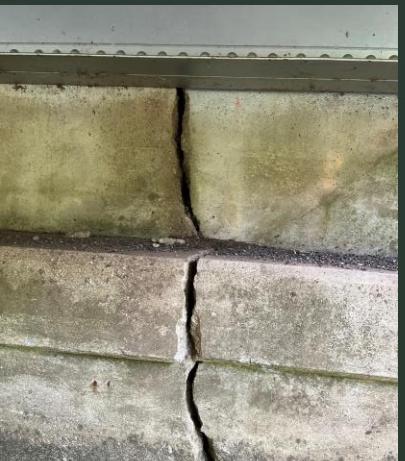
East Abutment –
Vertical Crack.

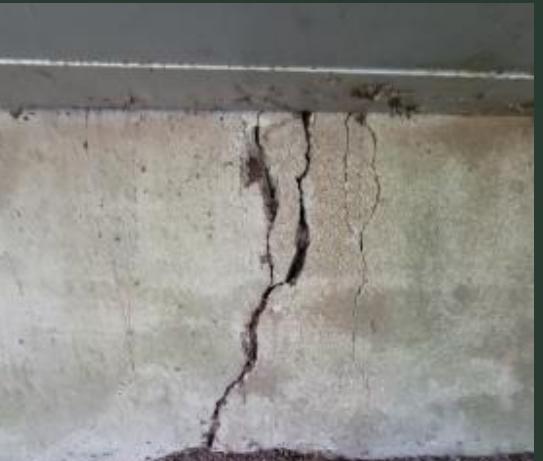
East Abutment – Vertical
Crack.

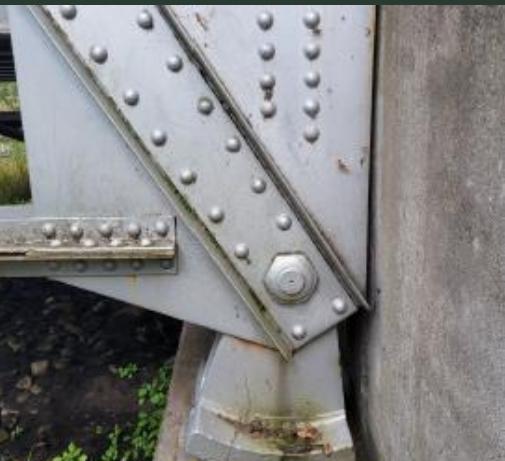
East Expansion Bearings.

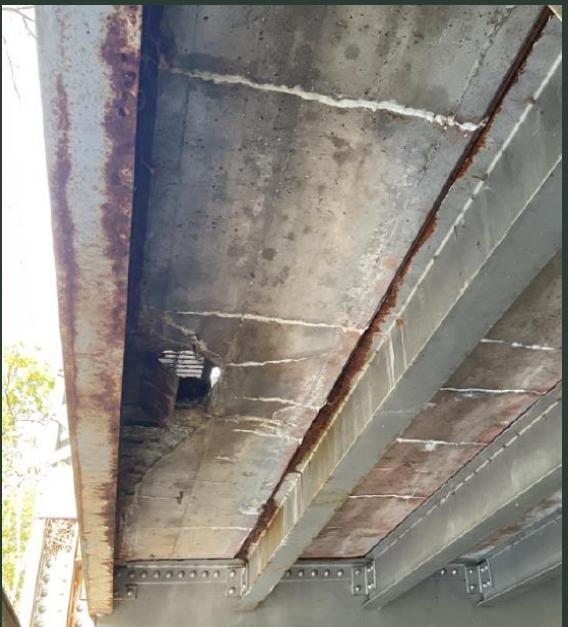
Typical Deck Cracking.

- The National Bridge Inventory (NBI) **condition rating** for the substructure, superstructure, and deck from 2024 was determined to be 3 (**serious**), 4 (**poor**), and 4 (**poor**) respectively, making the bridge structurally deficient.
- *NBI is a numerical rating that ranges from 0 to 9, where 9 represents a primary bridge component in excellent condition and 5 represents a minimum rating for a primary bridge component in fair condition. Ratings lower than 5 indicate components in deteriorated condition.*

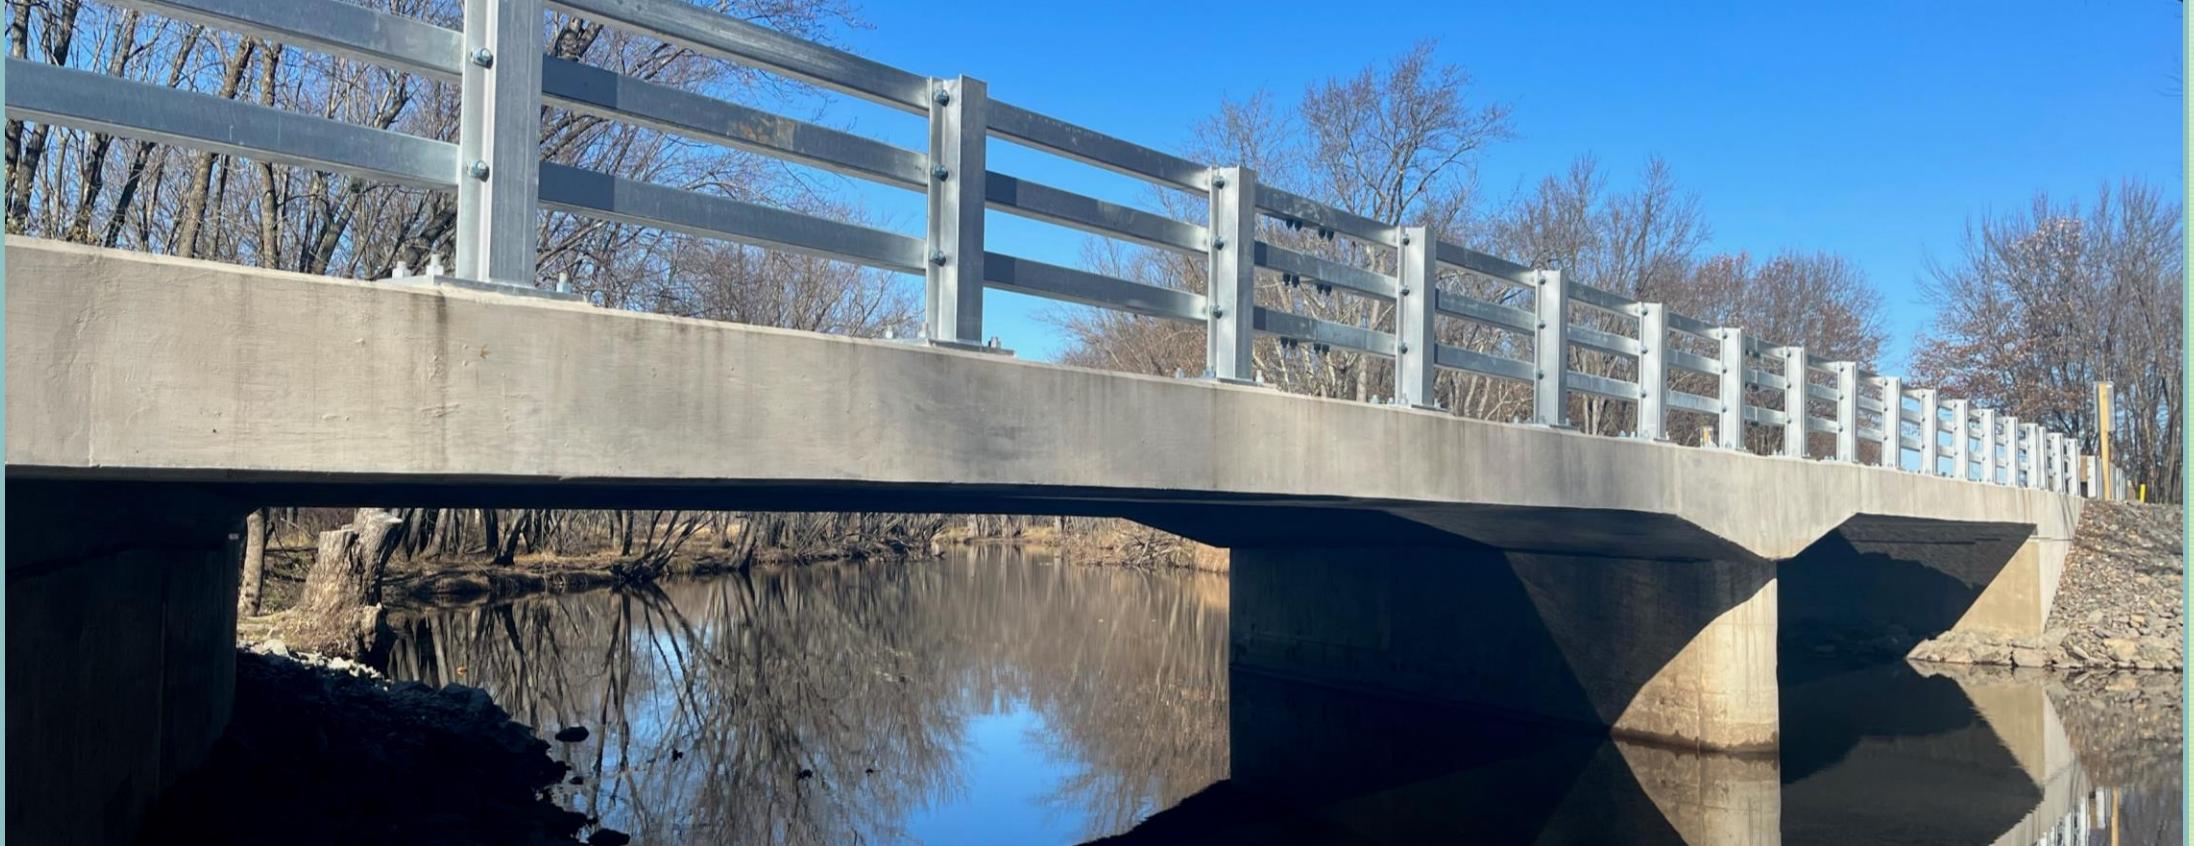
Rangeline Road over Little Eau Pleine River, Marathon County

EXAMPLE: Bridge Replacement
